# TIM'S TECH TIPS

## Gearbox Reseal/Repair

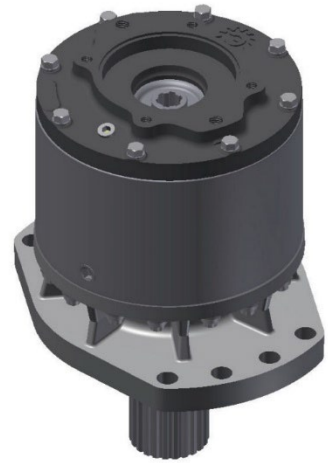
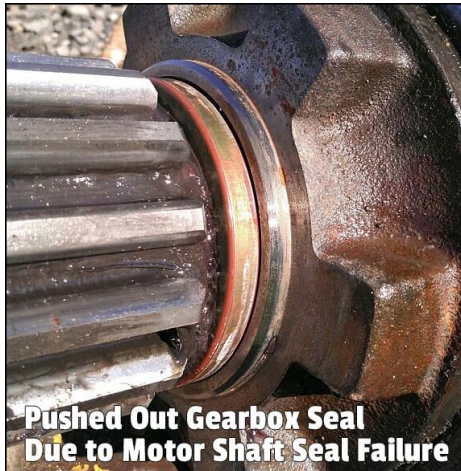
When a gearbox is pressurized by a blown motor shaft seal that pushes out the gearbox pinion seal, the gearbox needs to be resealed.

The typical cause for this is incorrect excavator case drain plumbing or when a rotate pressure line is connected to the case drain port. See the [\*\*Rotation Circuits Requiring a Case Drain Tech Tip\*\*](#) for proper installation.

Lack of routine gearbox oil changes and worn slewing ring gear teeth can also result in a gearbox needing repair or resealing. See the [\*\*Rotation Gearbox Maintenance Tech Tip\*\*](#) for recommendations.
