TIM'S TECH TIPS

Broken End Cap Bolts

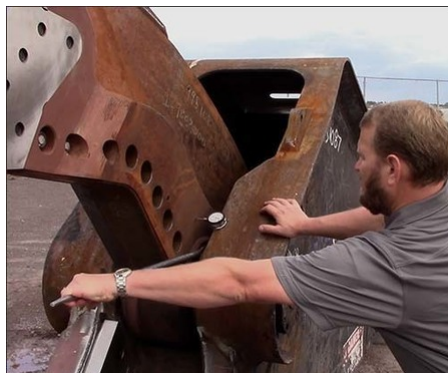
Worn main bearings can be a cause of pivot group end cap bolts failing on the guide side of an attachment.

The main bearing will wear more on the cutting side, causing the main shaft to start twisting toward the bearing on the guide side. The end of the main shaft will then contact the thrust washer under the cap at an angle instead of flat against it. This results in point-loading that will cause the end cap bolt heads to fail in the 6 to 9 o'clock positions on the end cap.

Checking both sides of the pivot group every 4 hours of attachment operation is recommended as standard maintenance while greasing, and if end cap bolts are damaged or broken, remove the caps and check for bearing wear.

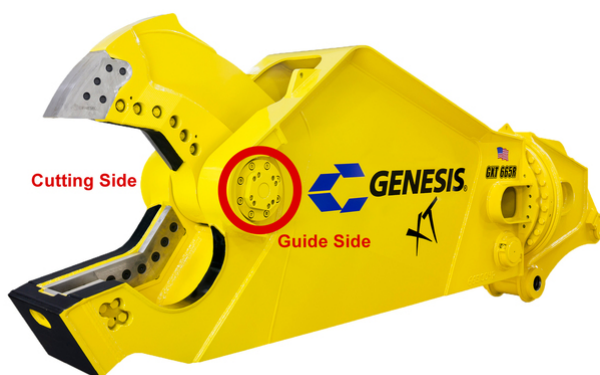
End cap bolt failure can also result from processing high-strength cable. The cable will not cut completely once the blades are dull and will wedge between the upper and lower main cutting blades. This puts extreme force between the blades and pushes the main shaft sideways into the end cap, popping off the bolt heads.
