Stuck Open Cross-over Relief Valves

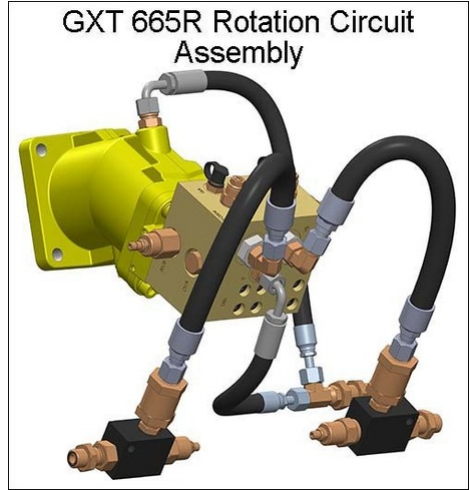
If you suspect this has happened, pull the two cross-over relief valves from the motion control valve assembly, clean them off and blow into each valve nose. If air passes through, it is stuck open.

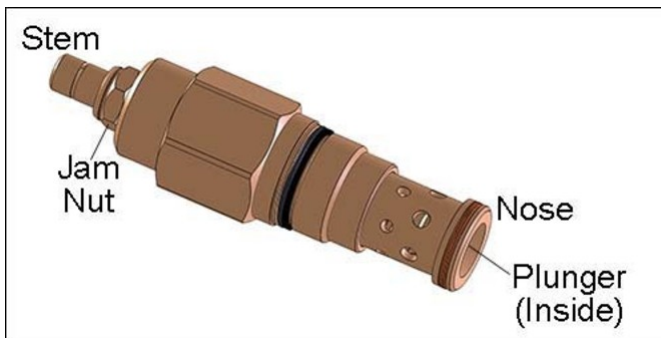
To remove the debris, put the valve nut body into a vise, crack the jam nut on the stem and back the stem out until it stops. Push down on the plunger with a screwdriver to unseat it from the valve nose while blowing air or brake cleaner through the ports. Try blowing air through it again and repeat the process until the plunger is seated and air will not pass through.

Turn the stem back to its original position and snug the jam nut. Install the valve back into the motion control manifold and torque to 150 ft lbs.
