Troubleshooting Swivel or Hydraulic Motor Leaks

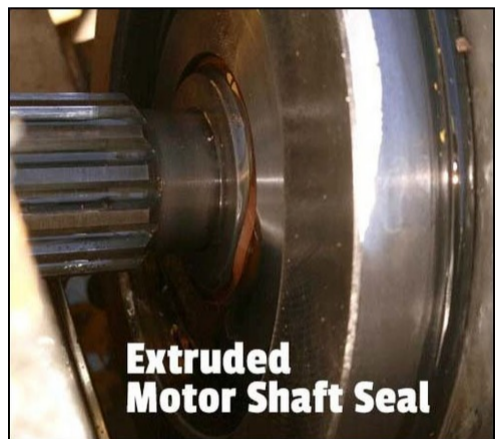
Whether the attachment has a direct drive motor or a motor gearbox combination, remove the four motor mounting bolts, slide the motor out and inspect the shaft seal for damage or protrusion from its bore. If there is no visible damage, secure the motor inside the head so the shaft doesn't contact other components and hoses.

Carefully inspect the motor shaft seal area while an operator rotates the motor from the cab. If the shaft seal is leaking, it must be replaced. If the attachment has a motor gearbox combination, the gearbox must be removed from the rotator head, and its seal must also be inspected and repaired.

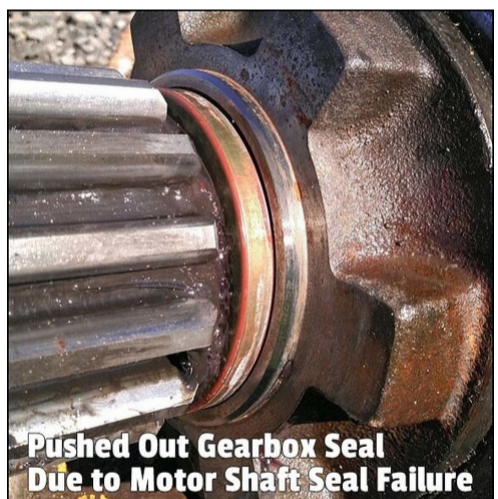
Motor shaft seal failures on a piston or gear motor are almost always due to plumbing issues, including the case drain being connected to a return circuit on the carrier instead of the suction side of the hydraulic tank or a rotate line being inadvertently connected to the case drain port on the attachment.

If a motor case seal failure is discovered, further investigation is usually required.
