## GXT Piercing Tip Installation

Piercing blade maintenance is crucial to productivity and safe shear operation. An improper blade gap may cause material jamming and/or blade breakage.

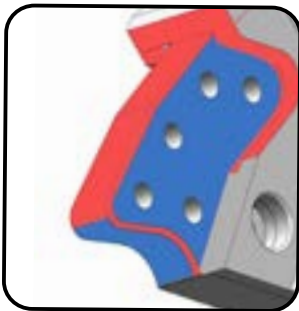
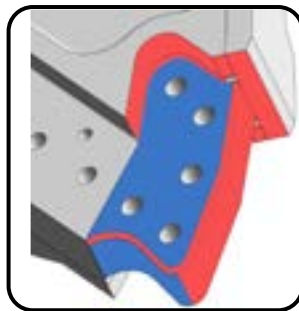
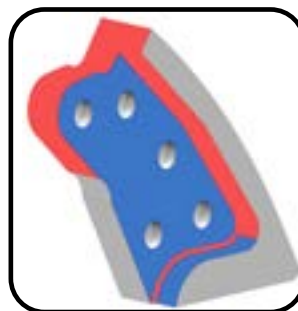
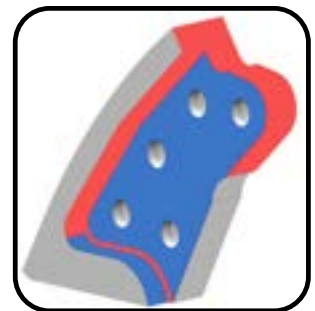
Areas **Highlighted in Blue** require contact fit to the upper jaw and tang to prevent shattering.

Areas **Highlighted in Red** require an air gap, and blades may occasionally need to be ground down to provide clearance.

Piercing blade contact with the clearance areas (**red**) can cause abnormal stress in the blade. This may cause the piercing and/or guide blades to crack, break or shatter.

When necessary, build up the front lower edge of the tang (areas **highlighted in yellow**), following the procedures in the [GXT Safety and Operator's Manual](#). After welding, surfaces should be squared with a grinder and finished with a file and a machinist's straight edge.
