GXT EVO Piercing Tip Installation

Piercing blades must fit tightly in some areas while having clearance in others. Piercing blades are made from the same material as the cutting blades to withstand the friction caused by piercing hard materials.

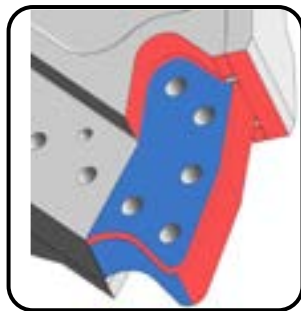
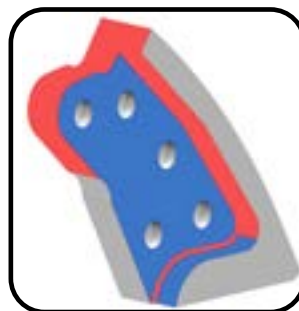
Areas **Highlighted in Blue** require contact fit to the upper jaw and tang to prevent shattering.

Areas **Highlighted in Red** require an air gap, and blades may occasionally need to be ground down to provide clearance.

Piercing blade contact with the clearance areas (**red**) can cause abnormal stress in the blade. This may cause the piercing and/or guide blades to crack, break or shatter.

When necessary, build up the front lower edge of the tang (areas **highlighted in yellow**), following the procedures in the [GXT EVO Safety and Operator's Manual](#). After welding, surfaces should be squared with a grinder and finished with a file and a machinist's straight edge.
